Flood Control Project Maintenance
2019 Structure Summary Report
Overall Unit and Item Ratings

Black Rascal Creek Drop Structure

Flood Control Project Maintenance
Unit Cover Sheet
2019 Structure Inspection Results

Levee Inspection Report By Mile - Structure 2019

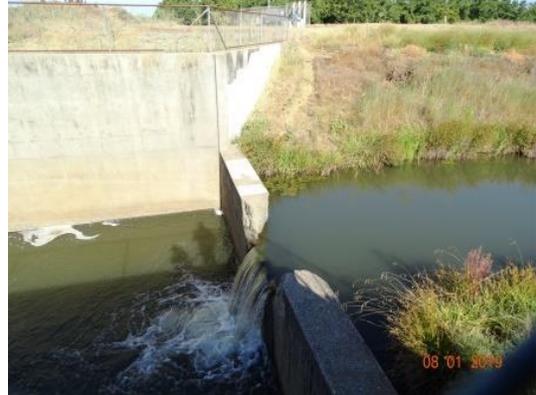
Photo 1 of 3 : ST_2019_NA0013_28_1_20190809_00012.jpg

View of drop structure from the left bank. Summer 2019

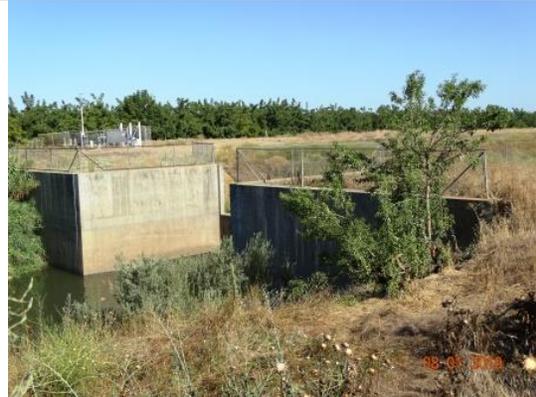
Photo 2 of 3 : ST_2019_NA0013_28_1_20190809_00013.jpg

View of abutments from left bank. Summer 2019

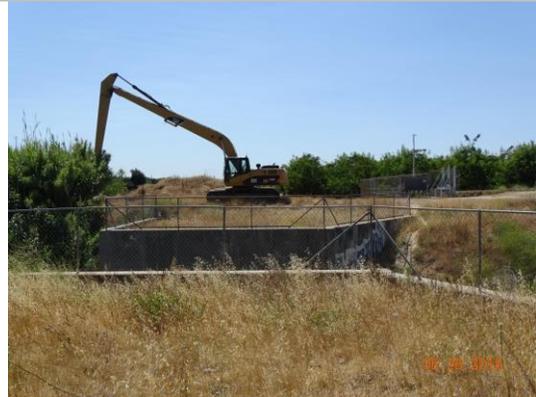
Photo 3 of 3 : ST_2019_NA0013_28_1_20190619_00002.jpg

View of abutments from left bank. Summer 2018

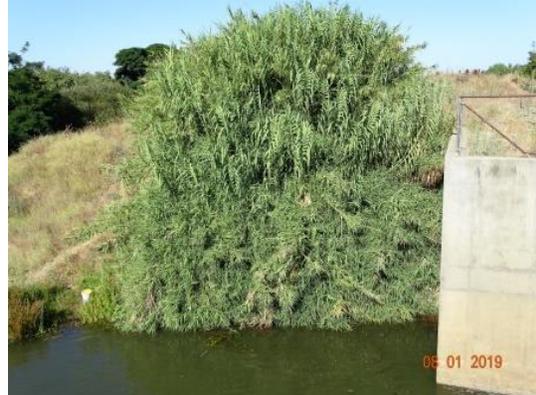
Photo 1 of 1 : ST_2019_NA0013_28_2_20190809_00014.jpg

LM Start	0.00	Rating **	A	Issue No.	2
LM End	0.00	Issue Type +	Ma	Location *	
Category	Structures & Concrete Lined Channels		GPS Latitude/Longitude		
			Start	End	
Item	Vegetation & Obstructions		37.314667 °	37.314667 °	
			-120.396101 °	-120.396101 °	
DWR ID	DWR_NA0013_28_t_2016_2				
Action/Comments					
Inspector Comments: Remove Arundo on the right bank downstream of the structure.

View of Arundo on right bank downstream of structure. Summer 2019

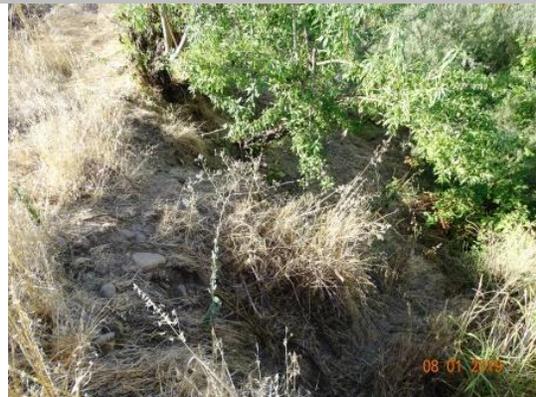
Photo 1 of 1 : ST_2019_NA0013_28_4_20190809_00016.jpg

LM Start	0.00	Rating **	M	Issue No.	4
LM End	0.00	Issue Type +	Ma	Location *	
Category	Structures & Concrete Lined Channels		GPS Latitude/Longitude		
			Start	End	
Item	Erosion / Bank Caving		37.314667 °	37.314667 °	
			-120.396101 °	-120.396101 °	
DWR ID	DWR_NA0013_28_t_2016_4				
Action/Comments					
Inspector Comments: Monitor erosion adjacent to left bank abutment.

View of minor erosion on the left bank adjacent to abutment. Summer 2019

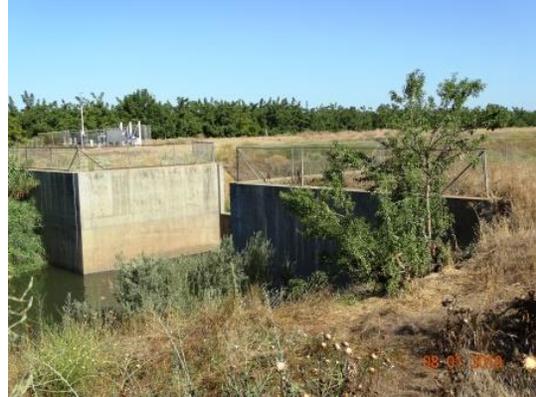
Photo 1 of 2 : ST_2019_NA0013_28_15_20190809_00018.jpg

View of left and right bank abutments. Summer 2019

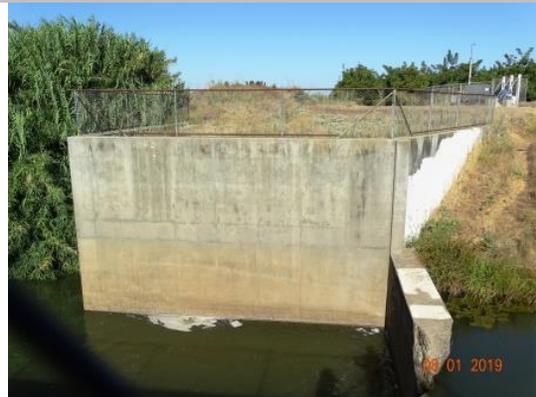
Photo 2 of 2 : ST_2019_NA0013_28_15_20190809_00017.jpg

View of right bank abutment. Summer 2019

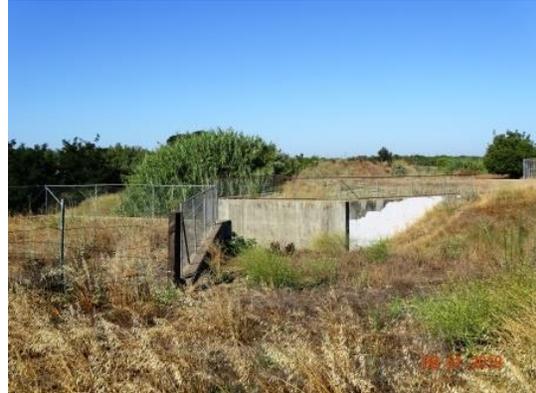
Photo 1 of 2 : ST_2019_NA0013_28_23_20190809_00019.jpg

View of fencing along both banks. Summer 2019

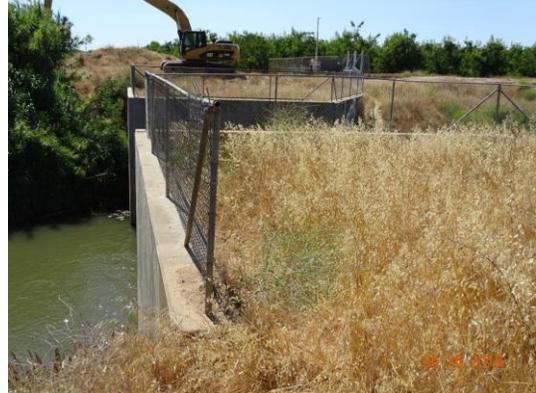
Photo 2 of 2 : ST_2019_NA0013_28_23_20190619_00009.jpg

View of fence along left bank. Summer 2018

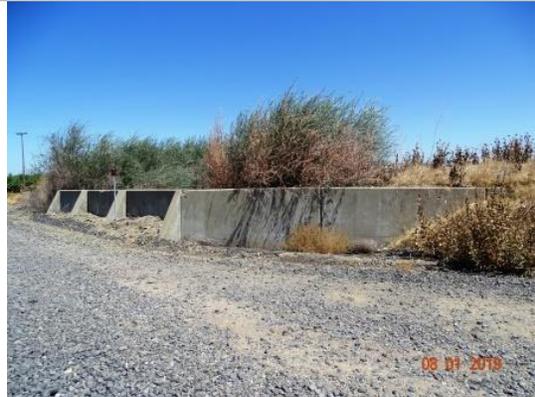
Photo 1 of 4 : ST_2019_NA0013_51_1_20190809_00012.jpg

View of the Owens Creek Siphon Structure from the east. Summer 2019

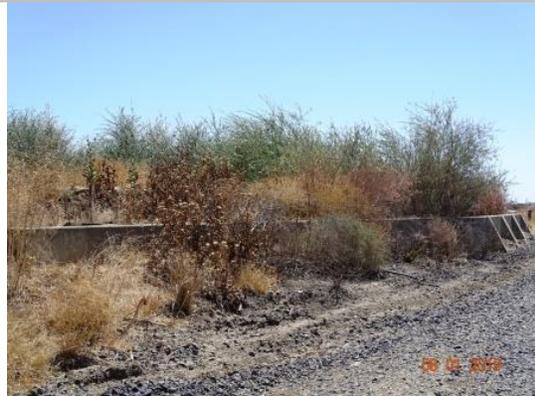
Photo 2 of 4 : ST_2019_NA0013_51_1_20190809_00013.jpg

View of the Owens Creek Siphon Structure from the west. Summer 2019

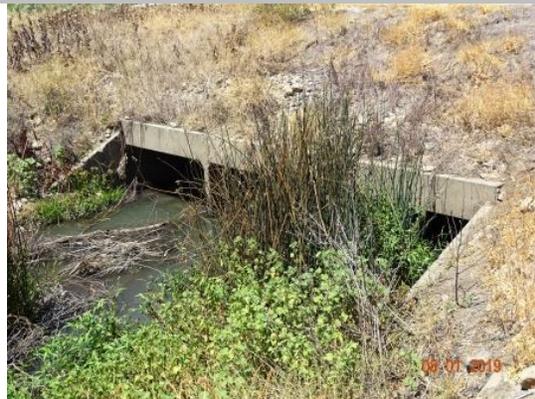
Photo 3 of 4 : ST_2019_NA0013_51_1_20190809_00014.jpg

View of the outlet of the siphon structure. Summer 2019

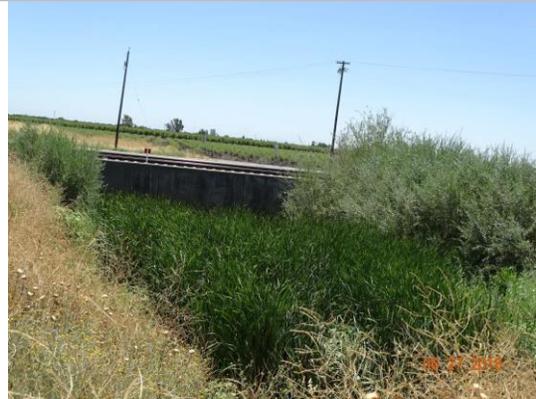
Photo 4 of 4 : ST_2019_NA0013_51_1_20190619_00001.jpg

View of siphon inlet structure. Summer 2018

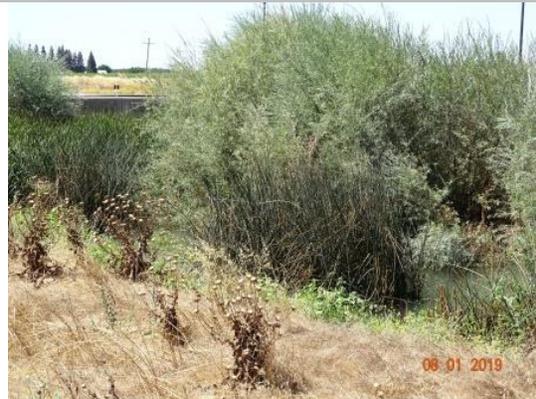
Photo 1 of 4 : ST_2019_NA0013_51_2_20190809_00015.jpg

LM Start	0.00	Rating **	U	Issue No.	2
LM End	0.00	Issue Type +	Ma	Location *	
Category	Structures & Concrete Lined Channels			GPS Latitude/Longitude	
				Start	End
Item	Vegetation & Obstructions			37.262648 °	37.262648 °
				-120.288194 °	-120.288194 °
DWR ID	DWR_NA0013_51_t_2016_2				
Action/Comments					
Inspector Comments: Woody vegetation and log jams may impede flows.

View of vegetation obstructing view of inlet. Summer 2019

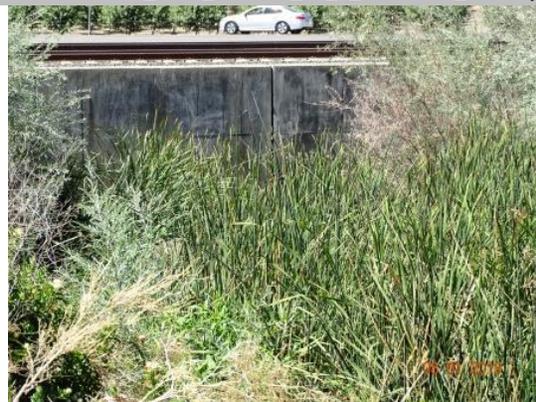
Photo 2 of 4 : ST_2019_NA0013_51_2_20190809_00016.jpg

View of vegetation obstructing view of inlet. Summer 2019

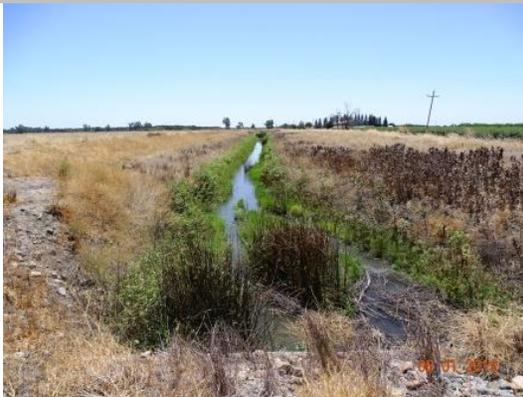
Photo 3 of 4 : ST_2019_NA0013_51_2_20190809_00017.jpg

LM Start	0.00	Rating **	U	Issue No.	2 (cont)
LM End	0.00	Issue Type +	Ma	Location *	
Category	Structures & Concrete Lined Channels		GPS Latitude/Longitude		
			Start	End	
Item	Vegetation & Obstructions		37.262648 °	37.262648 °	
			-120.288194 °	-120.288194 °	
DWR ID	DWR_NA0013_51_t_2016_2				
Action/Comments					
Inspector Comments: Woody vegetation and log jams may impede flows.

View of vegetation downstream of structure. Summer 2019

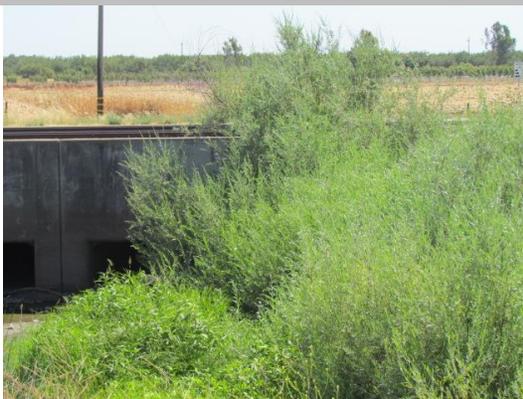
Photo 4 of 4 : ST_2019_NA0013_51_2_20190619_00009.jpg

Looking at the vegetation on the right bank of the inlet. Summer 2017

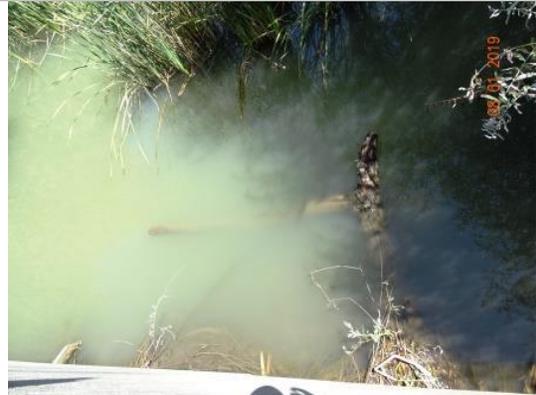
Photo 1 of 2 : ST_2019_NA0013_51_7_20190809_00020.jpg

LM Start	0.00	Rating **	M	Issue No.	7
LM End	0.00	Issue Type +	Ma	Location *	
Category	Structures & Concrete Lined Channels		GPS Latitude/Longitude		
			Start	End	
Item	Culverts: Inlets / Outlets		37.262648 °	37.262648 °	
			-120.288194 °	-120.288194 °	
DWR ID	DWR_NA0013_51_t_2016_7				
Action/Comments					
Inspector Comments: Remove tree log and other debris at the inlet and outlet.

View of tree log and debris at the inlet. Summer 2019

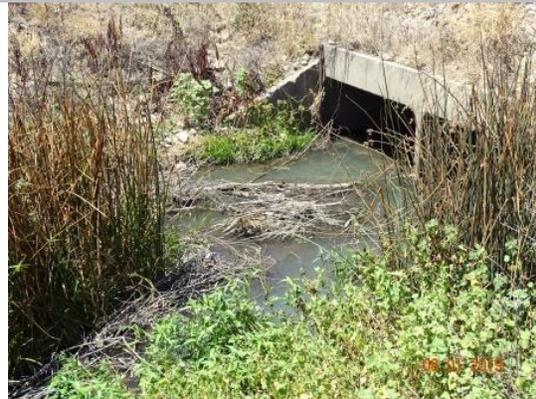
Photo 2 of 2 : ST_2019_NA0013_51_7_20190809_00019.jpg

View of debris at the outlet. Summer 2019
